Manhole Inspection Summary

Manhole # S21Y__003MH

Insp Date: **11/21/08 10:24 AM**

Location Address: **2101 WICOMICO ST**

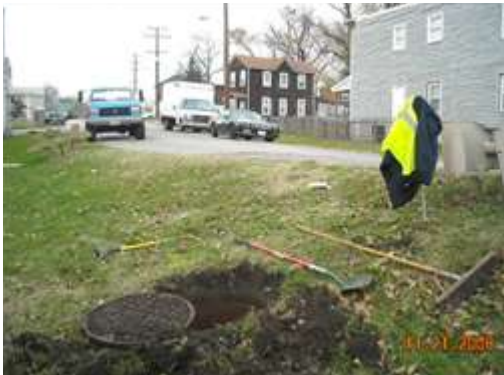
Location View

Comments **FRAME BELOW GRADE 4-8 INCHES; SLOPED GRASS AREA**

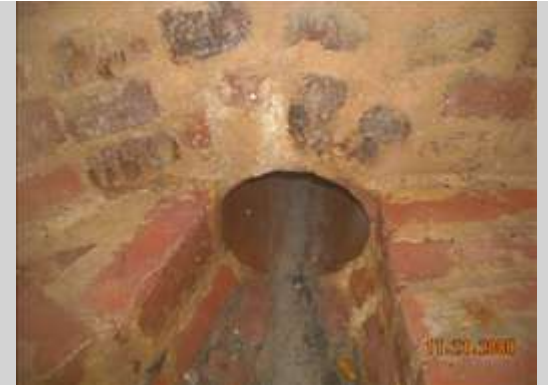
12 O'Clock Outflow

8 in. Circular Gravity Sewer
Pipe Out @ 12 O'Clock

Pipe Height: **8.4** (in.) Rod and Bar (Angled)
Pipe Material: **Clay** ☐ Pipe Lined
Invert Depth: **11.95** (ft.) Flow Characteristics: **Slow**
Deposits: ☒ None ☐ Mud ☐ Sludge ☐ Debris ☐ Grease
Silt Depth: **0** (in.) Deposits Extent:
Infiltration: **None** Pipe Seal Cond: **Sound**

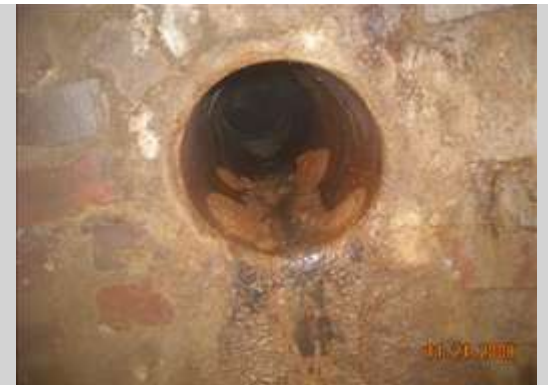
4 O'Clock Inflow

8 in. Circular Gravity Sewer
Pipe In @ 4 O'Clock

Pipe Height: **8.4** (in.) Rod and Bar (Angled)
Pipe Material: **Clay** ☐ Pipe Lined
Invert Depth: **7.95** (ft.) Flow Characteristics: **Slow**
Deposits: ☒ None ☐ Mud ☐ Sludge ☐ Debris ☐ Grease
Silt Depth: **0** (in.) Deposits Extent:
Infiltration: **None** Pipe Seal Cond: **Unknown**

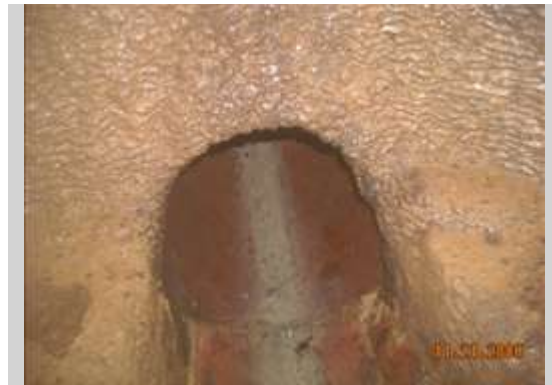
Drop In @ 4 O'Clock

Drop: **Outside** Rod and Bar
Angled: **Yes** Reading: **10.40** (ft.)
Inv Depth: **11.40** (ft.)
Drop Condition: **Open**
